**HELI**

**OPERATION SERVICE  
MANUAL**

**G3 Series Lithium Battery Counterbalanced  
Forklift Trucks**

**4-5t**

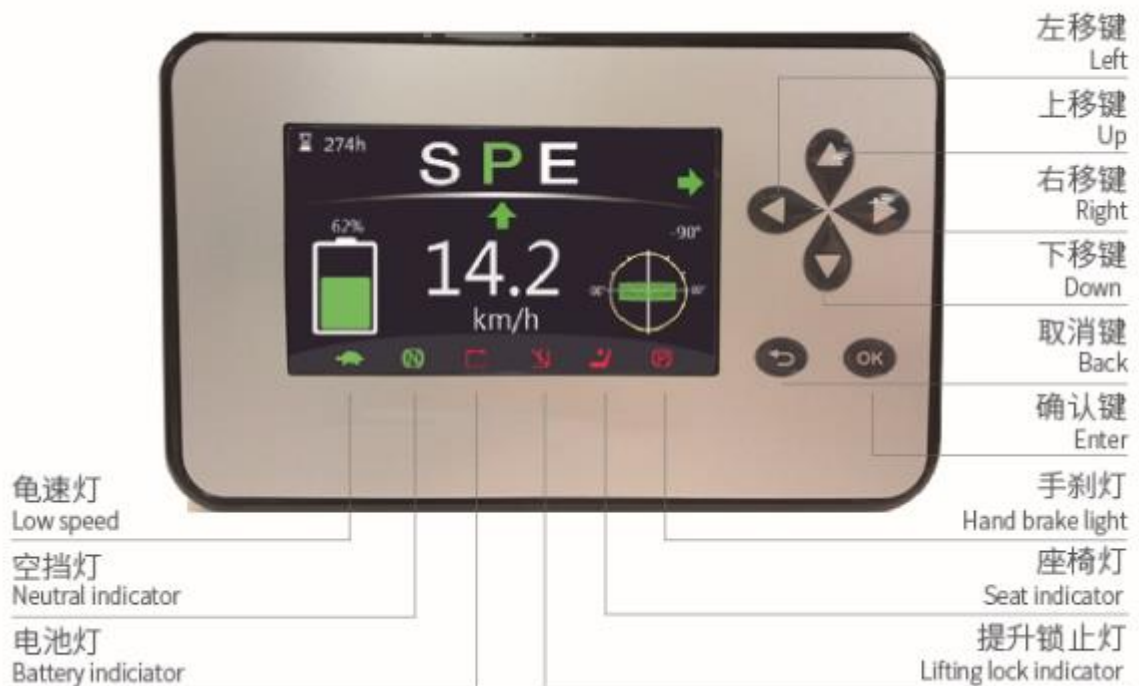
Fig.4-3 Introduction of Panel layout

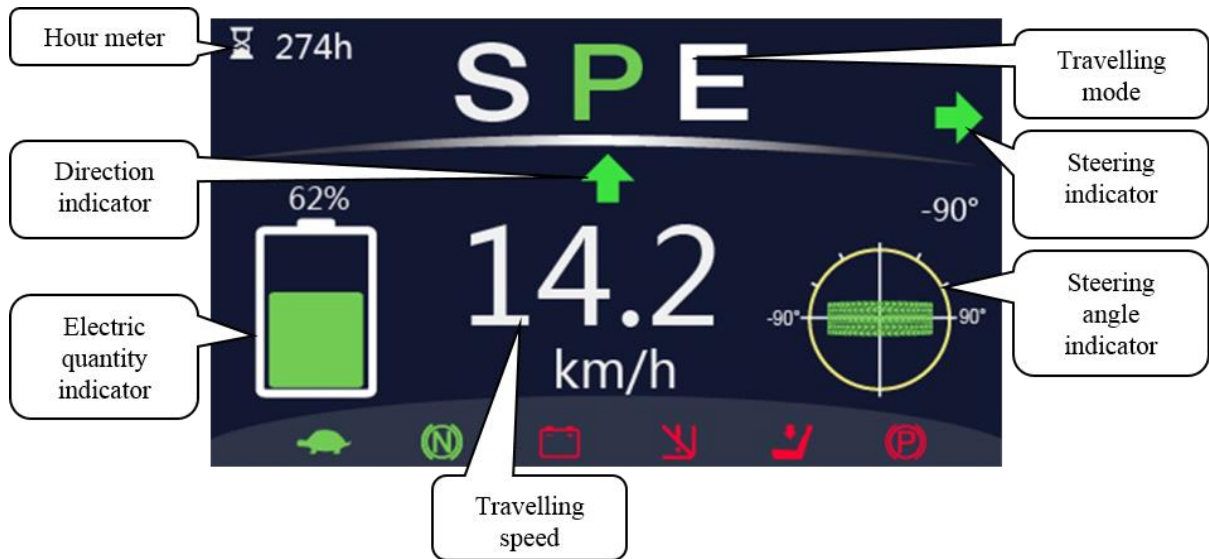
Fig. 4-4 Instrument interface display information introduction

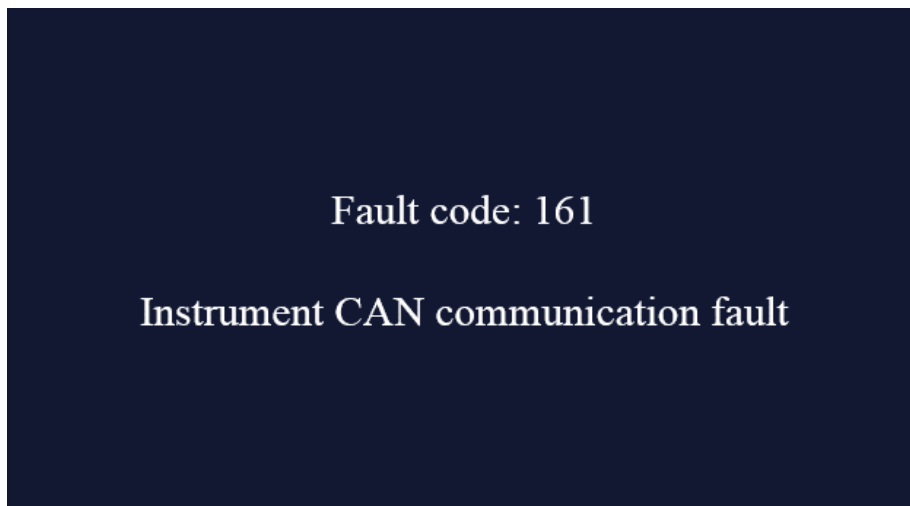
Fig. 4-5 Instrument interface-fault display

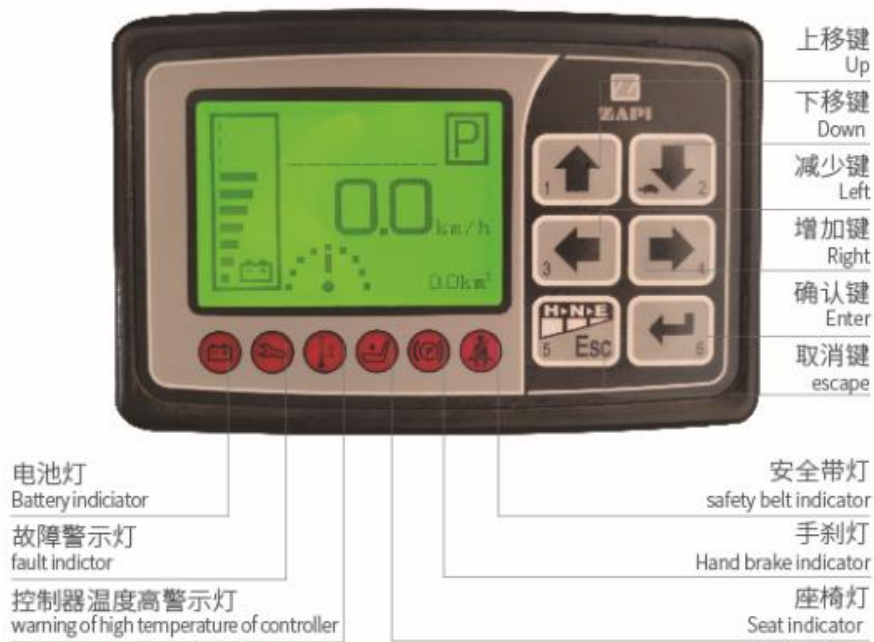
Fig. 4-6 Instrument panel introduction

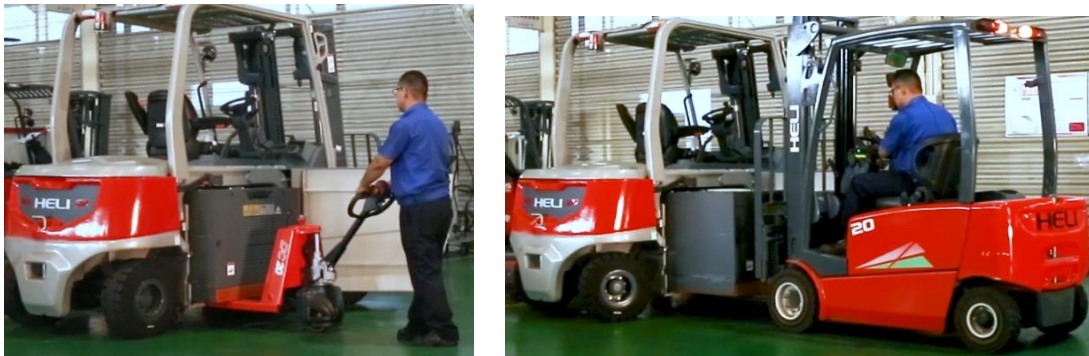
Lithium battery is the energy source of the truck. When the working intensity is high and the operation duration is long, the lithium battery needs to be replaced. The lithium battery can be changed from the right side of the truck body by forklift, electric pallet truck, pallet stacker and other tools. The replacement efficiency is high, as shown in the following figure.

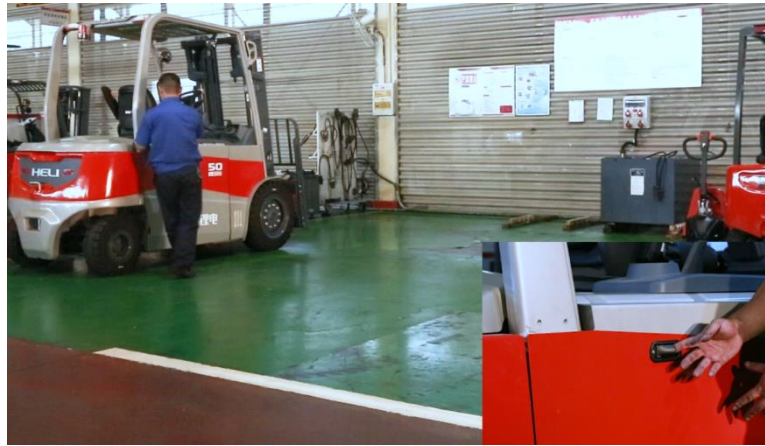
(1) Open the side door.

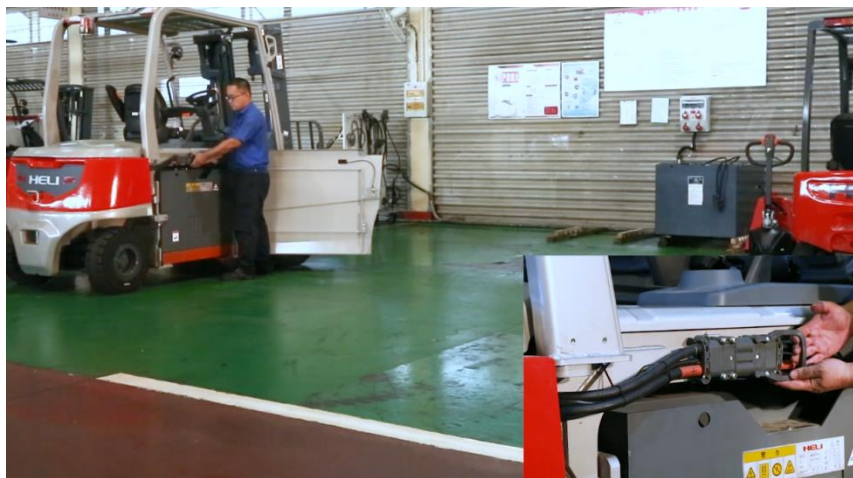
(2) Disconnect the lithium battery connections.

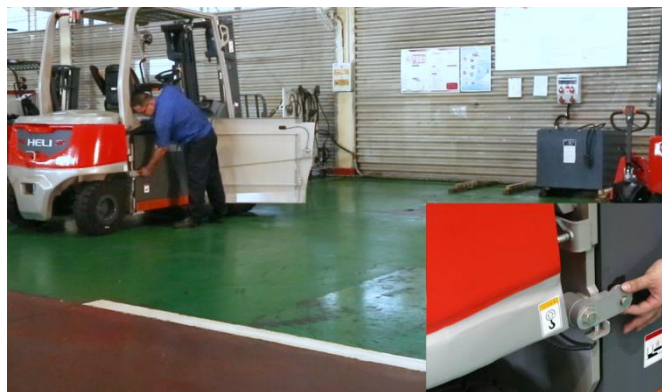
(3) Loose and remove the lithium battery limit block.

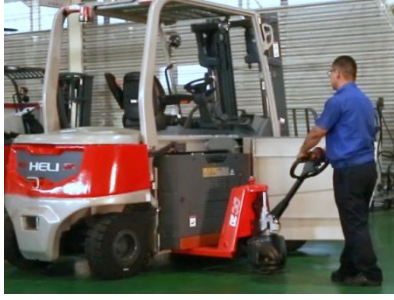
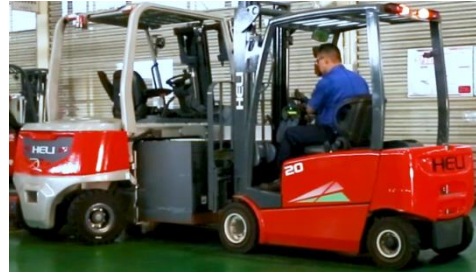
(4) Pick up the lithium battery with forklift truck, electric pallet truck or pallet stacker.

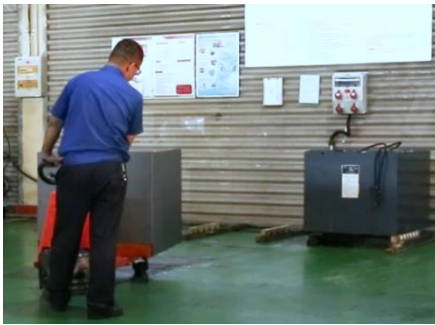
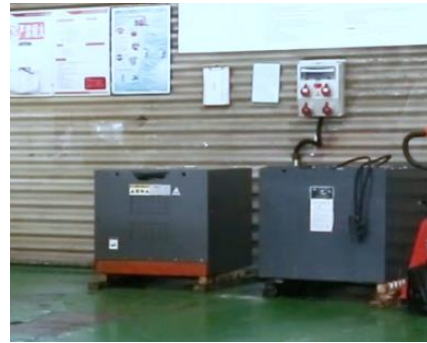
(5) Remove the lithium battery from the compartment and place the lithium battery on pre-prepared carrier. Please reserve enough space for fork in and out.

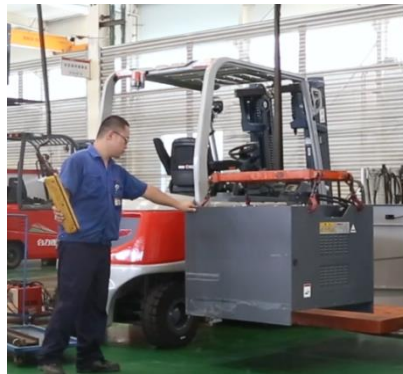
(6) Use the crane to separate the lithium battery pack from the bottom counterweight

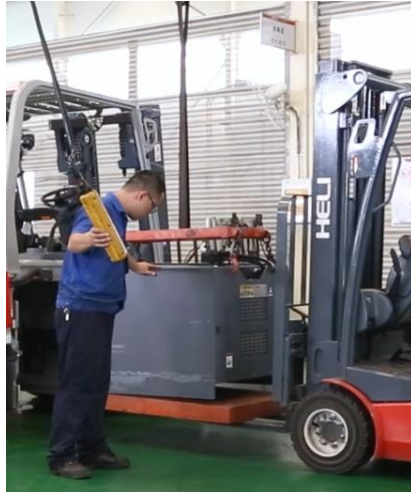
(1) Install the lithium battery pack together with the auxiliary counterweight by crane.

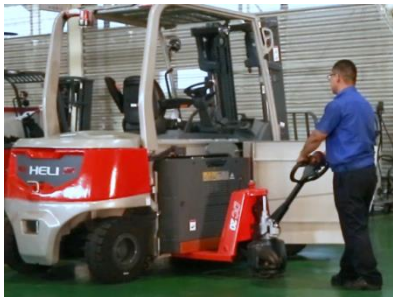
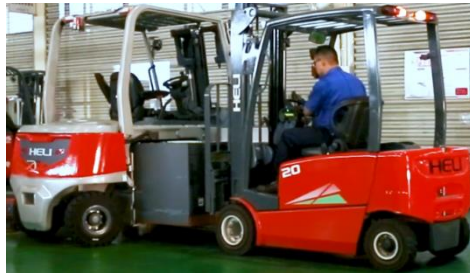
(2) Transport the lithium battery pack to the battery warehouse by pallet truck or forklift truck.

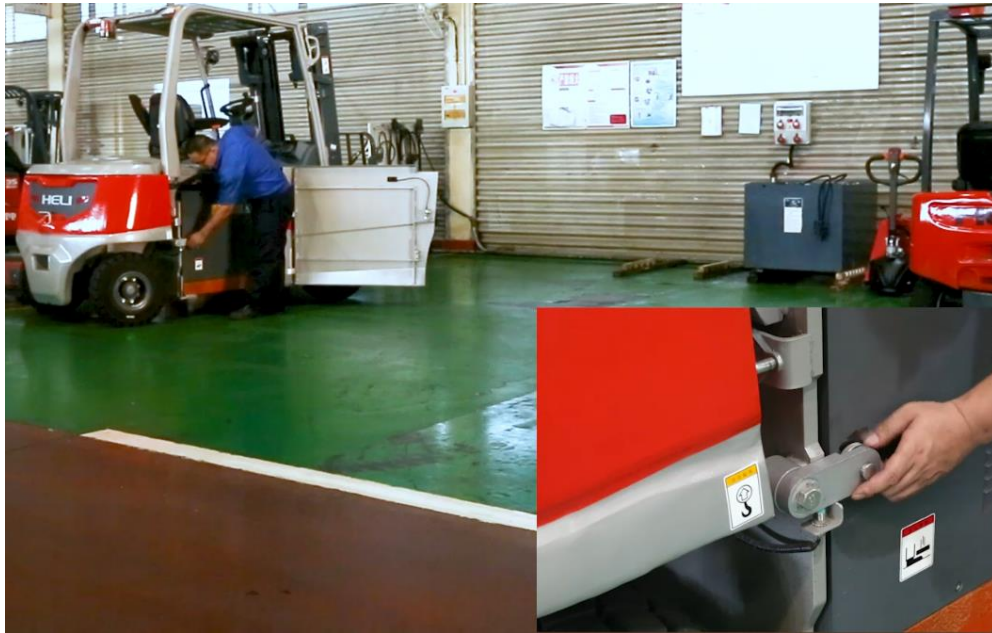
(4) Put down lithium battery limit block and adjust the limit screw to the end face of the lithium battery box.

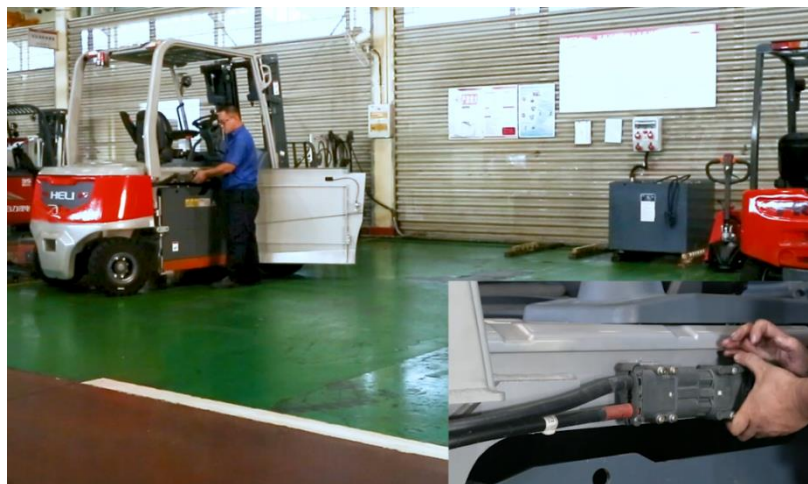
(5) Connect the battery.

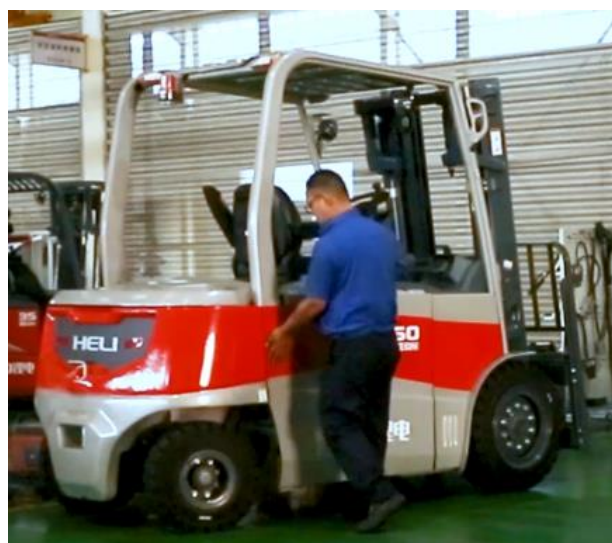
(6) Close the side door.
